# SHATIS 22

PROCEEDINGS OF  
6<sup>th</sup> INTERNATIONAL CONFERENCE ON STRUCTURAL  
HEALTH ASSESSMENT OF TIMBER STRUCTURES  
7th – 9th September 2022, Prague

# Proceedings of the SHATIS 2022 – 6th International Conference on Structural Health Assessment of Timber Structures

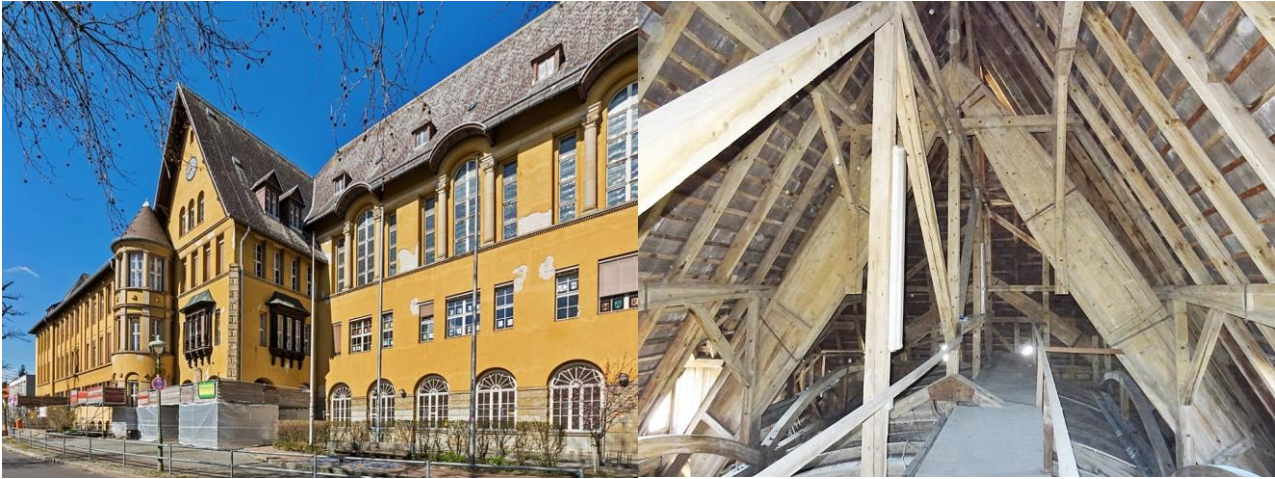
Figure 2: Fichtenberg Oberschule, Berlin/Germany – left: exterior view; right: view on the historic roof konstruktion

In addition to the investigations described above, the strength grading methodology was applied in comparative material test on sample material from historical, partially deconstructed timber structures (see [16, 17] and Figures 2 & 3). In the course of this, it was determined that minor adjustments to the methodology are necessary with regard to the consideration of the load-bearing capacity-reducing growth and component characteristics.

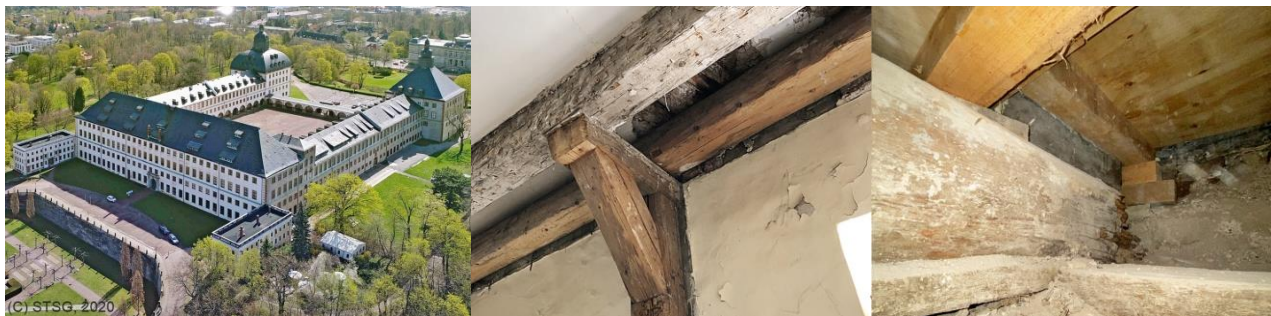
Figure 3: Castle Friedenstein, Gotha/Germany – left: aerial view; right: view on the examined ceiling construction

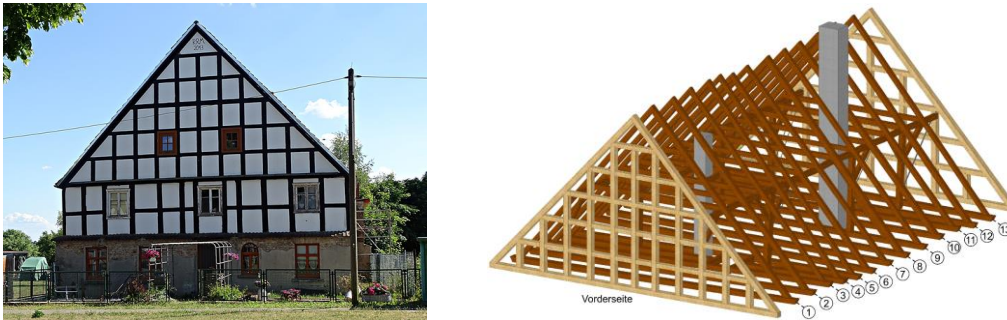
Figure 1: Exterior view of the aisled house (left) and isometric view on the roof construction (right)

are supported and braced on a double standing stool. These consist of an upper frame as well as three struts with head bands and occasional riser bands between the ceiling beams and columns. The gable trusses are half-timbered. The roof structure was made entirely of pine wood. The components come from several older buildings, which can be seen in the great variability of the component cross-sections as well as the numerous recesses in the component surfaces. The latter include notches for piles and mortises with no visible current use.

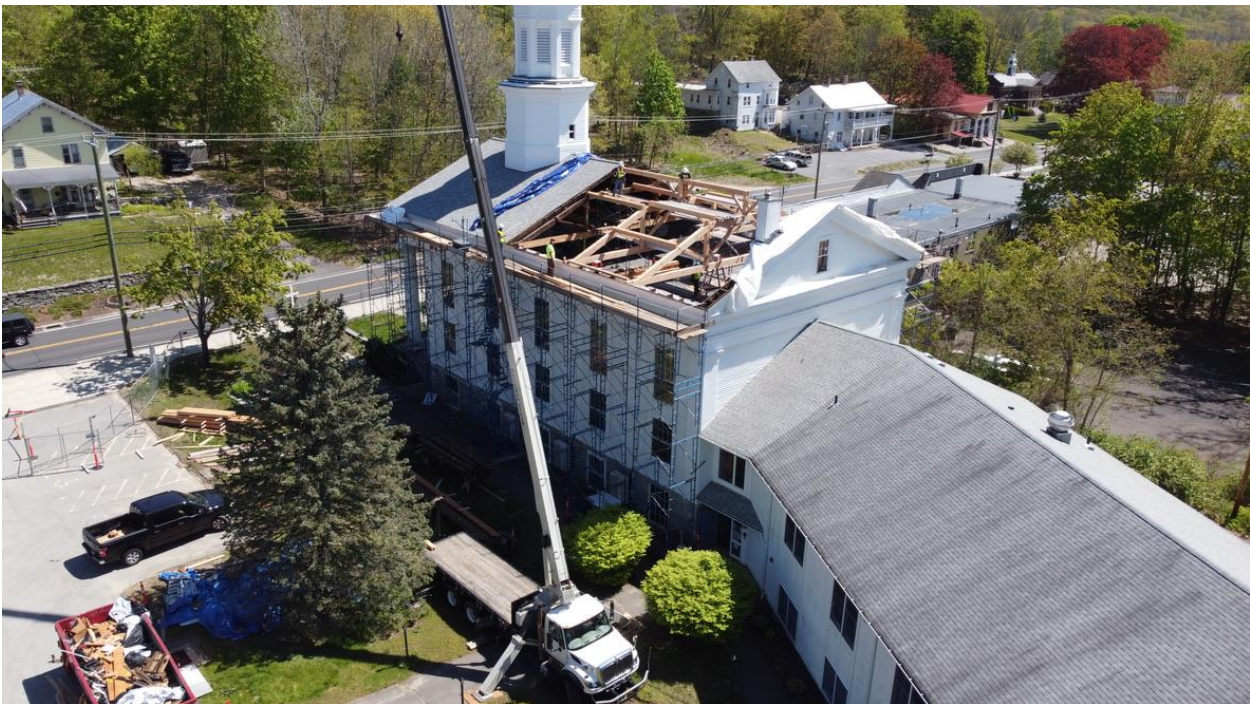
*Figure 2: Repair Work Underway – following methodology determined by IPM.*

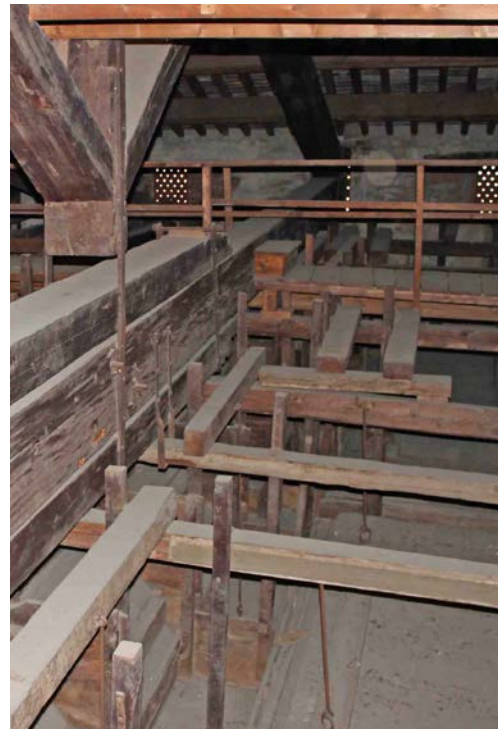
Figure 2: Anchoring system of the coffered ceiling.

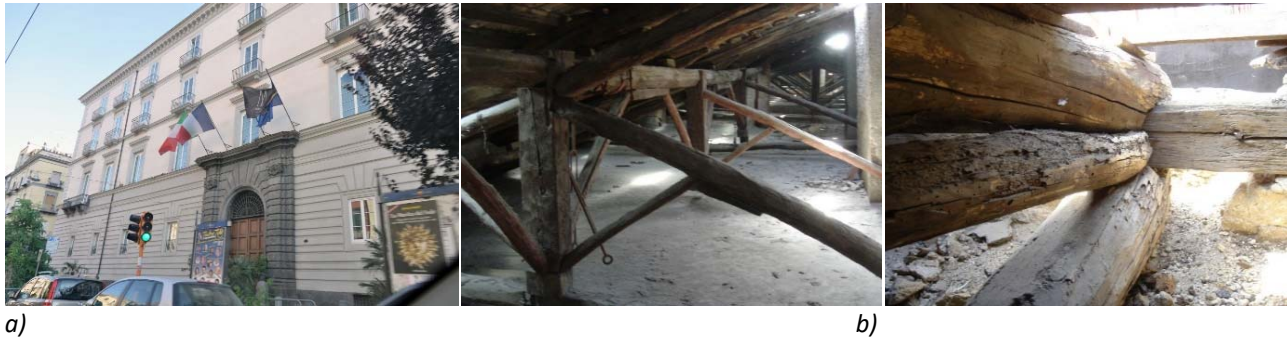
Figure 2: a) Palazzo Caracciolo (Naples); b) The study trusses

1). The intermediate floors and foundation haven't been identified since they were not investigated. The roof is a simple way system with secondary beams supported by main trusses, the roof structure is in-plane deformable, without bracing system, the presence of pushing elements and tie beam are recognized. Structural members have a single section. The closing elements are tiles. The building has 4 stories, with average interstorey height ranging between 3.5-5m. It has a destination of use for public utility activities (section C; Fig. 3).

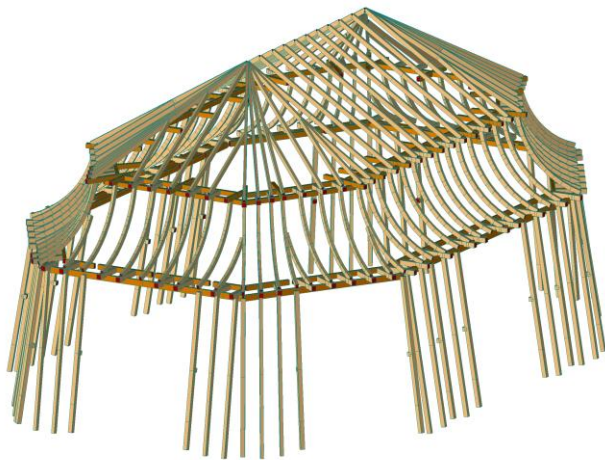
(a) Rafters and purlins

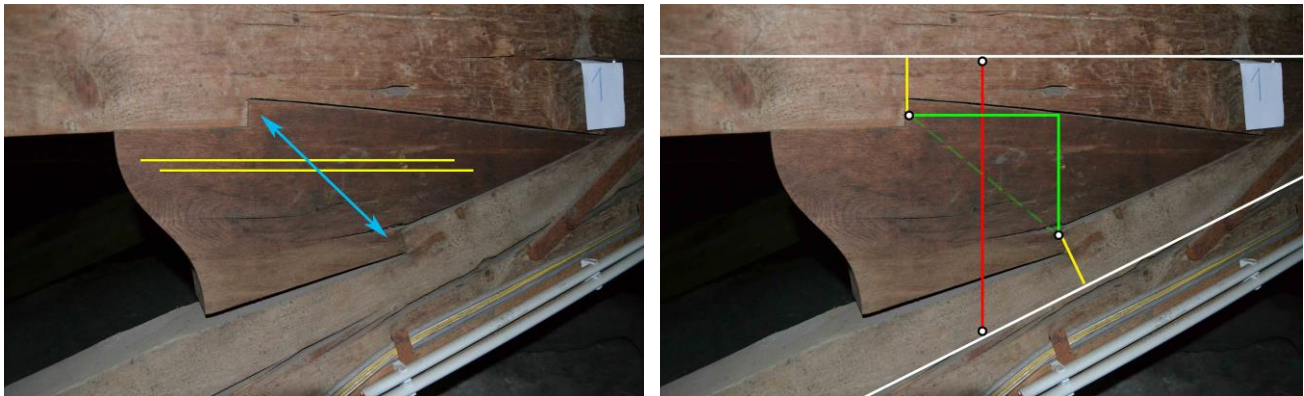
(a) Triangular block of oak:  
Grain direction (yellow) and  
compressive force (blue)

(b) Corresponding structural modelling (1D elements):  
Beam axis (white), eccentricities to points of load  
transfer (yellow), angled rigid element reflecting fi-  
bre orientation (green) and clamping element (red)

Joints with *tenons and/or scarf joints* are realized by hinges without any capacity to take tensile loads. In the case of compressive normal forces parallel to the beam axis, the hinges are switching to rigid.

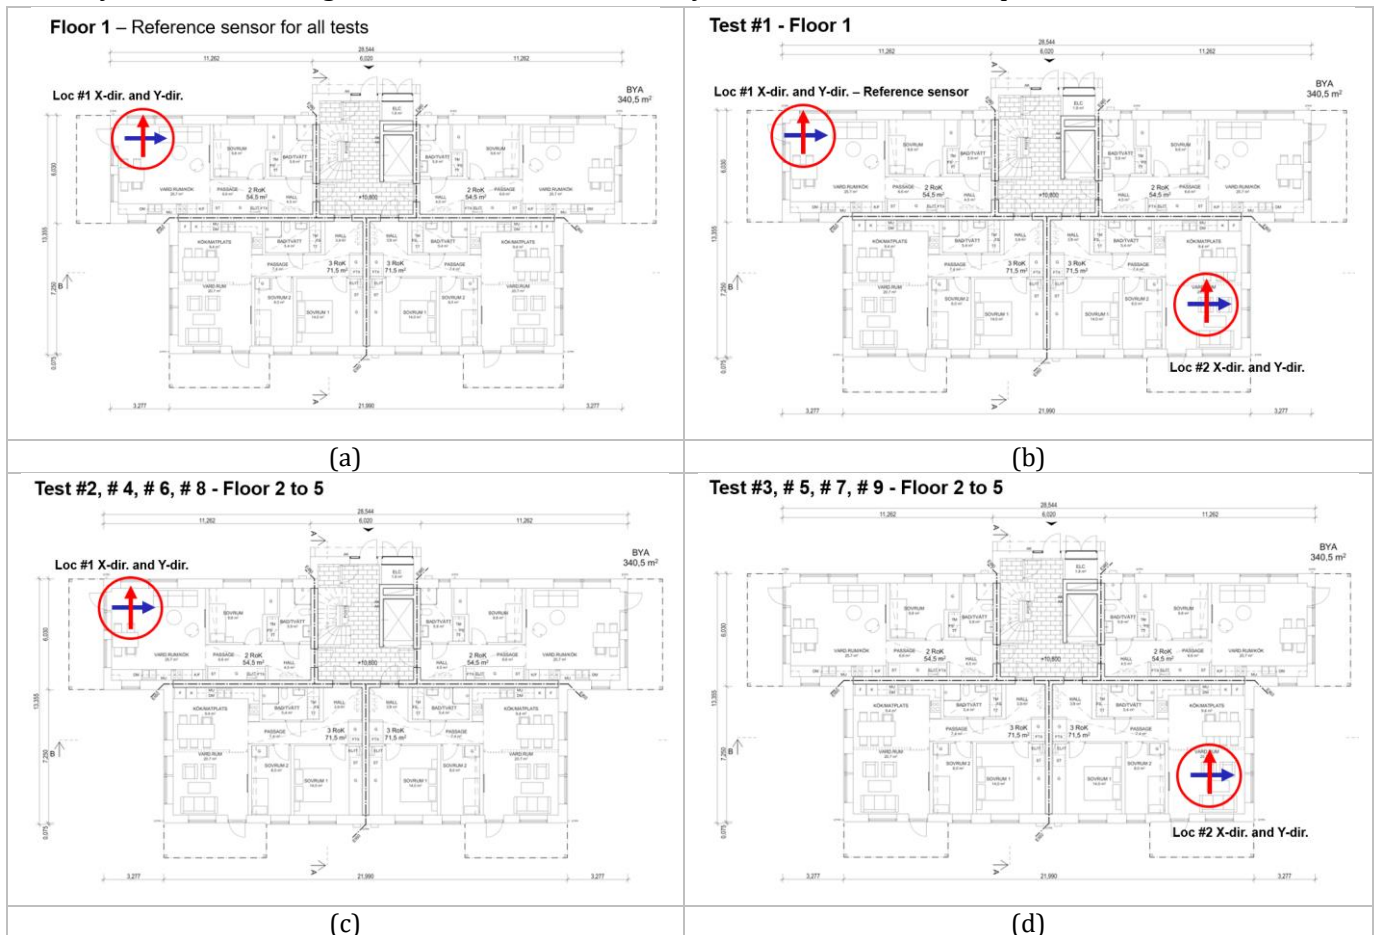
Figure 3: Floor plans with sensor locations: (a) Reference sensor location for all tests; (b) Test setup #1 Floor 1; (c) Test setup #2, #4, #6, #8 Floor 1 to 5; (d) Test setup #3, #5, #7, #9 Floor 1 to 5

Due to the limited number of accelerometers, nine different tests were performed on the building to record the accelerations at each level while keeping fixed the reference system at the level 1. Figure 3 from (a) to (d) shows the different test setups for each measurement, showing the X and Y positive direction. For each test setup, the ambient accelerations were collected for approximately 30 min. with a sampling frequency of 120 Hz. The sensor layout was selected based on a preliminary numerical analysis of the building in order to be able to identify the torsional mode shapes.

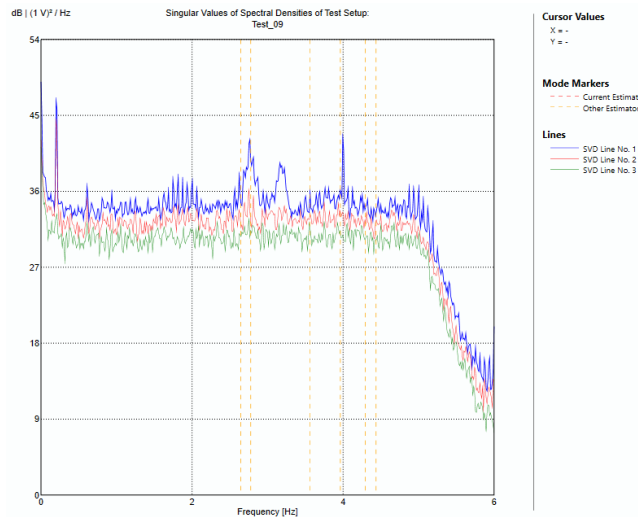
Figure 4: Singular Value Decomposition (SVD) plots for the Test Setup #9 used for the EFDD method.

For the EFDD method, Figure 4 shows the Singular Value Decomposition (SVD) obtained for the test setup #9. Two well defined peaks can be observed at the frequency range between 2 - 4.0 Hz.

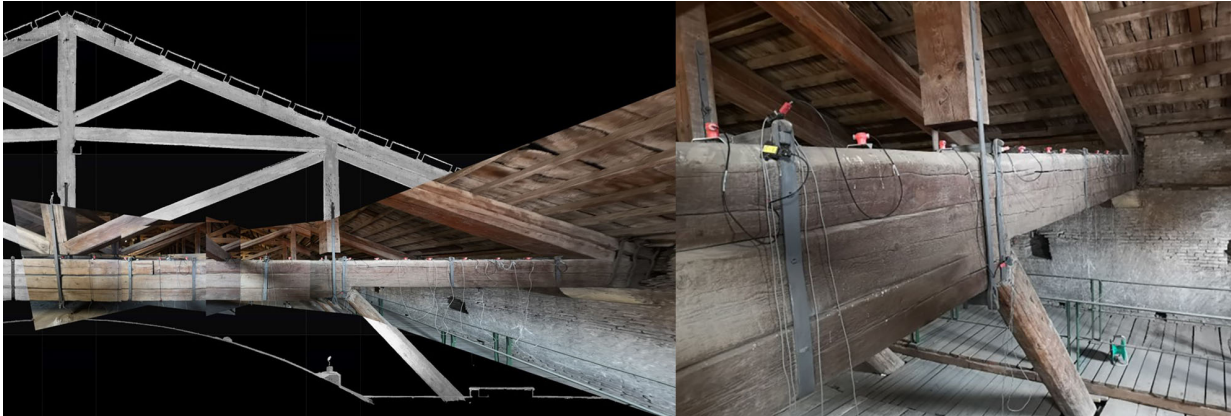
Figure 3: One of the 18 inspected timber trusses of the San Pietro cathedral in Bologna. Placement of vertically polarized geophones connected to a SoilSpy digitizing system. @Prati, Isani, 2019

- 40 single-station ambient vibration acquisitions on the perimeter walls of the Cathedral. We set the seismometers within niches on the walls and in the centerline of the tie beam of each truss,
- one multichannel seismic acquisition along the tie beam longitudinal axis of truss number 2 (Figure 3),

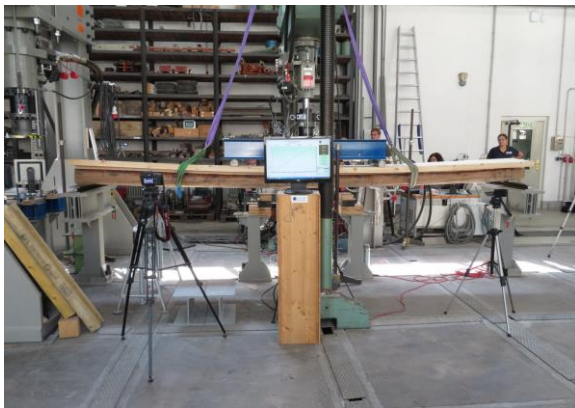
Figure 4: 4-point bending test, beam- scale 1:2

The experimental investigations on a scale of 1:2 included examinations of the load-bearing behaviour and the vibration behaviour of the strengthened beams. The load-bearing behaviour was tested using a 4-point bending test arrangement in the Otto Mohr Laboratory at TU Dresden. The test was carried out on two test beams (Fig. 5) under a path-controlled load until failure. The clear fracture in the tensile zone of the composite section and the achieved average fracture load of  $96,2\text{ kN}$  at an average deflection of  $65.3\text{ mm}$  prove the load-bearing capacity of the strengthened beam and show that the new technology can be used to produce a load-bearing, structural bonding.

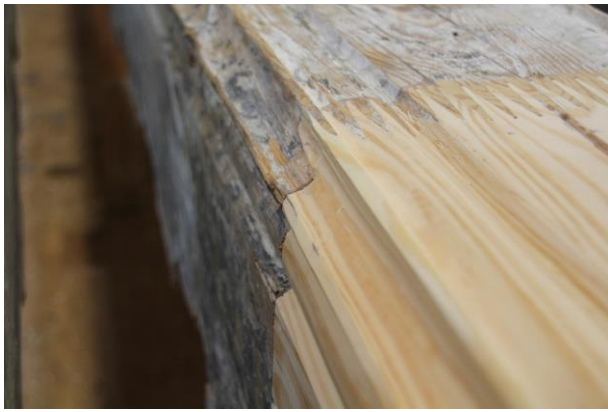
Figure 6: Detail with a finger joint

This situation, means that the beams can be prepared while removed. Repairing them in the factory has the advantage that finger jointing can be used between the historical beam pieces and the new wooden additions. The disadvantage of conventional joints is that most use metal fasteners with joint slip and a large transition area between the components to be connected. A finger joint is a load-bearing connection without any slip and requires only a small connecting area of  $5\text{ cm}$ , so the polychrome painting is still preserved.

The repair of the historic ceiling beams was completed by extending the shaping to the new beam sections (Fig. 6; Fig. 7).

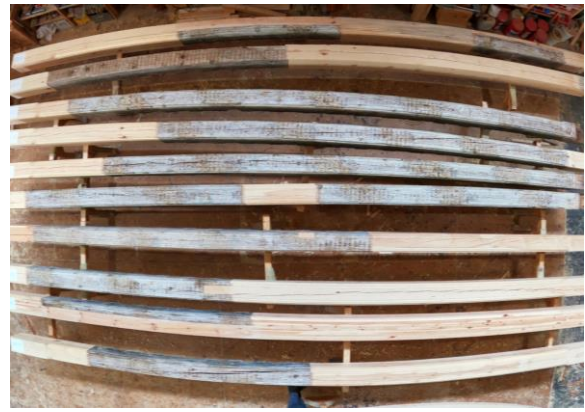
Figure 7: View of the beams - shaped surface at the top (Photo taken with a fisheye)

The strengthening measures that follow involve preparing an adhesive surface on the top of the beams, including levelling out the deformations on the repaired rectangular beams. The height of the adjustment planks is individually adapted to the specific beam, so that the glue-laminated timber elements are at the same height and the ceiling boards between the beams can be integrated into the ceiling after the restoration (Fig. 8). The bonding is carried out in line with the results of the preliminary investigation using screw-press bonding. When the strengthening work is completed, vibration tests are to be carried out directly in the factory hall and compared with the requirements and the experimental test. The knowledge and experience gained in repairing and strengthening the beams will be applied to the other ceilings in Pałac Sztynort.

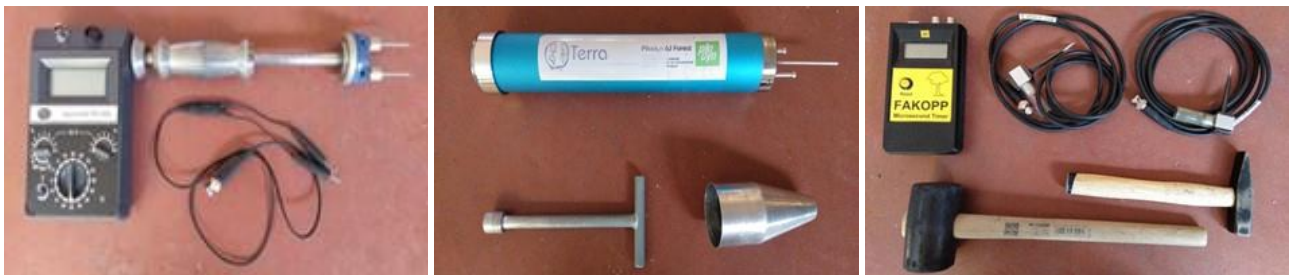
Figure 3: Resistive xylohygrometer (left), Pilodyn (centre), MST (right)

To obtain the values corresponding to the pieces of the whole structure, 10 pieces of each floor were analysed without xylophagous attacks (a total of 30 pieces), taking 3 measurements in each piece and at different points. Moisture content was measured with a resistive xylohygrometer, figure 3.

Density was measured with a specific penetrometer for wood (Pilodyn) applying the equation (1) from Llana *et al.* [9].

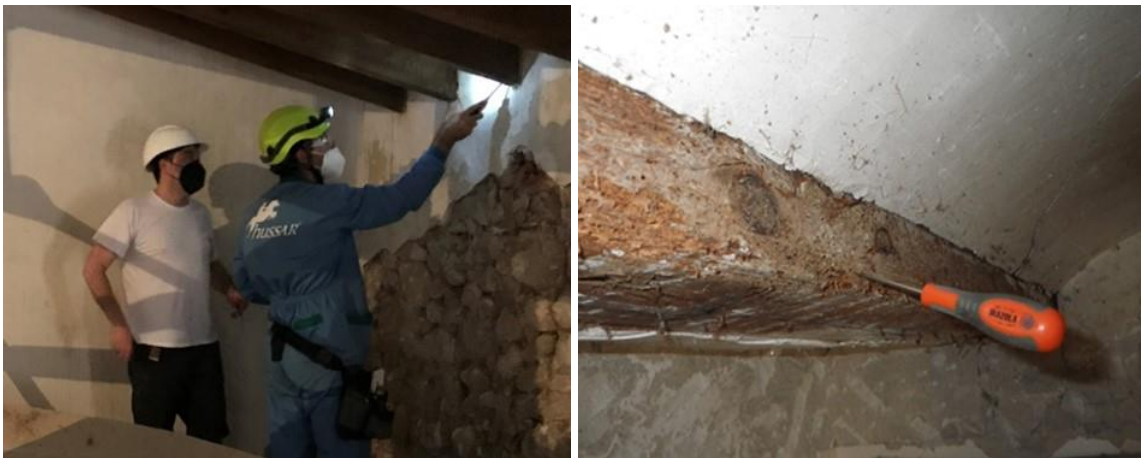
*Figure 4: Punch and screwdriver inspection*

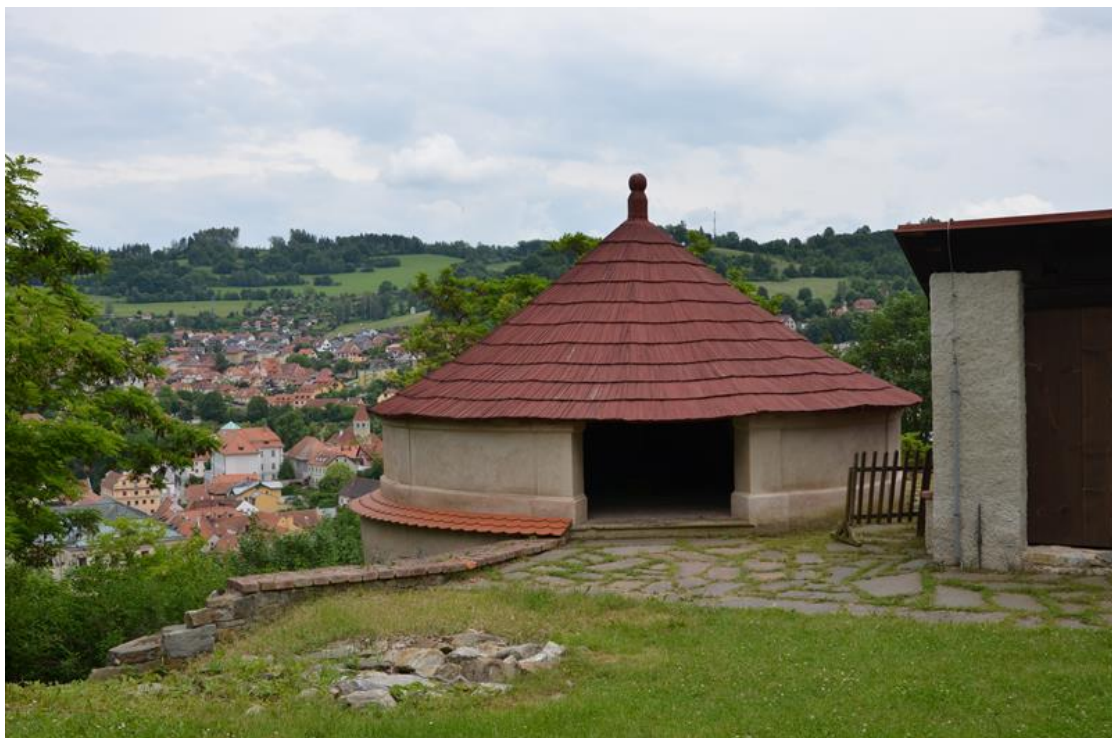
*Figure 1: A view of the gazebo with its roof fully lowered, photo Jiří Bláha, 2022.*

Most of the buildings of the Český Krumlov castle complex are now accessible to its visitors. However, some parts are still waiting to be rediscovered, such as the former Mountain Garden established on a steep slope above the Vltava River around 1800. Here, near the gardener's house, orangery and supply garden, there are two gazebos, both of early 19th-century origin [4]. One of them is the so-called Rindenhaus, a light shelter made of round fir poles and originally covered with sheets of bark. It offered an intimate meeting place, framed by natural scenery, with a wonderful view of the city, the castle and the surrounding countryside. The second lookout place is located 140 m south from there and adjoins a stone masoned storage building partially nestled into the sloping terrain. This gazebo offered impressive views of the town as well. However, unlike the bark house, it could also be used for larger social gatherings. The structure has the form of a large parasol, with a shingle roof supported by a massive central post of octagonal cross-section. Its traditional name Paraplíčko is a Czech diminutive derived from the French word *parapluie*, meaning literally "a tiny umbrella". The gazebo is notable primarily for its ingenious rocker mechanism, hidden in the basement space, that allowed the entire roof to be raised in a few minutes in good weather and quickly lowered again if necessary, for example during rain. In wintertime, it was possible to leave the roof completely dropped down to the parapet wall height (Fig. 1).

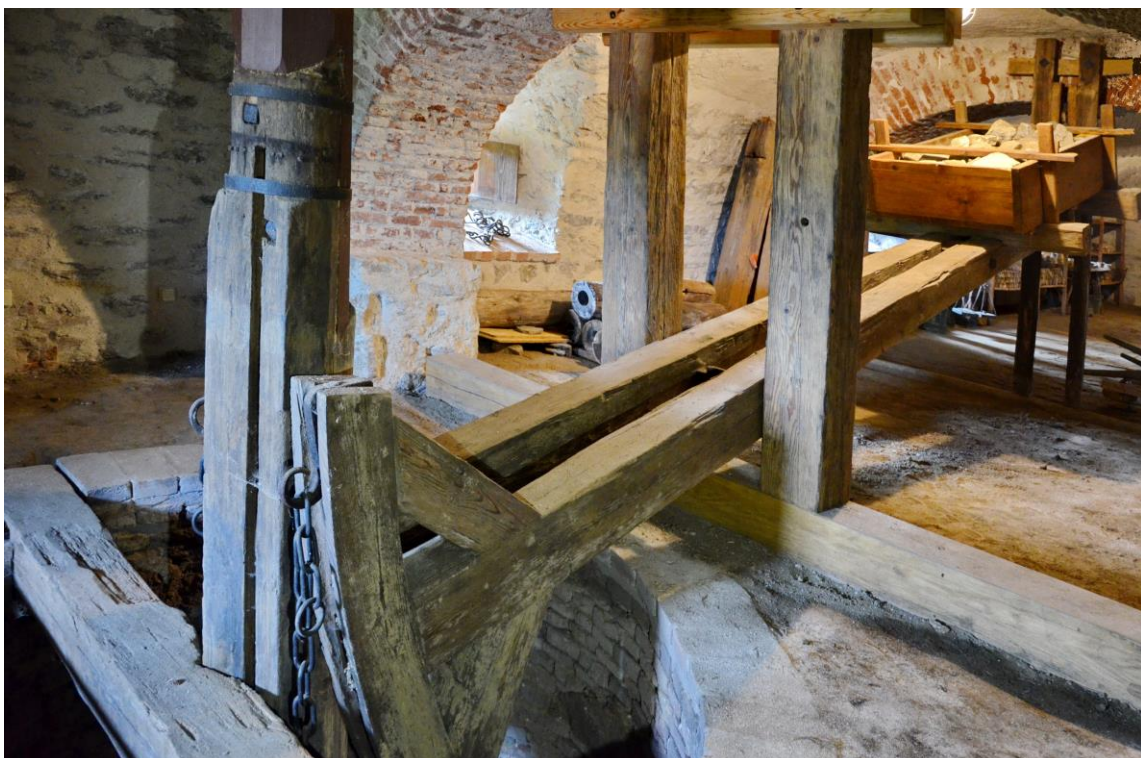
*Figure 4: Lifting mechanism in lowered position. Hinge of the principal post in foreground, counterweight box in the background, photo Jiří Bláha, 2022.*

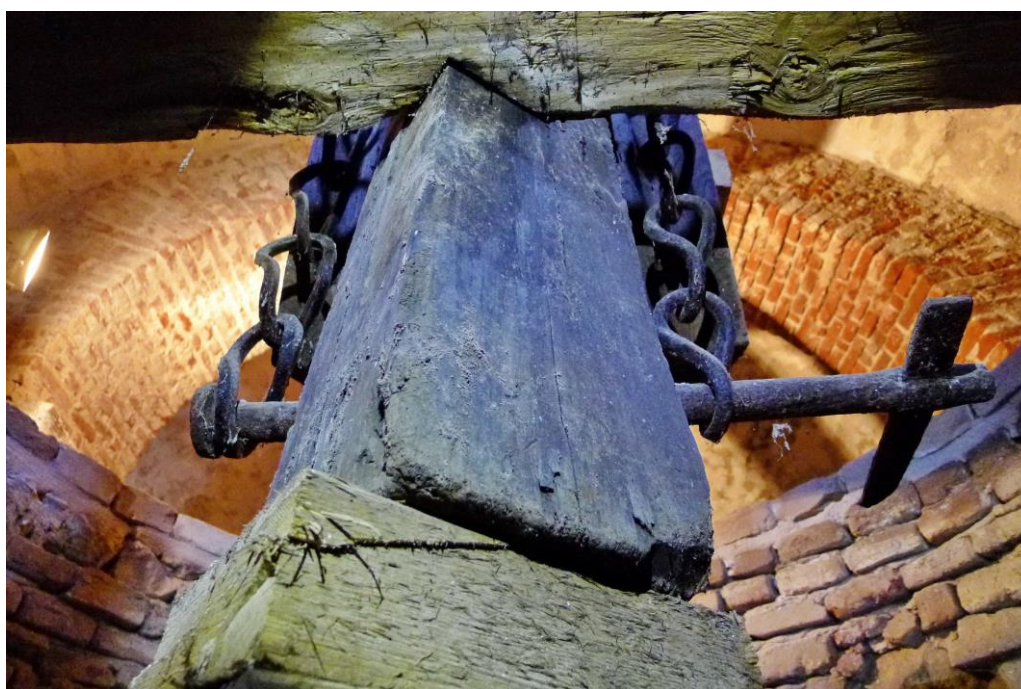
*Figure 5: Bottom view of hinge at the lower end of the main post guided by the notch in the transverse beam, photo Jiří Bláha, 2015.*

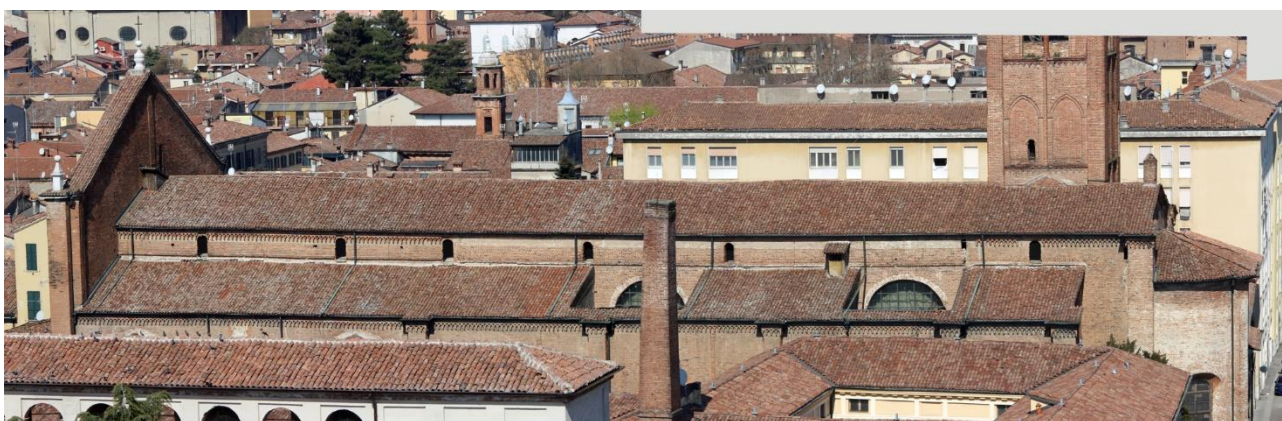
Figure 2: Photomosaic of the southern side of the church.

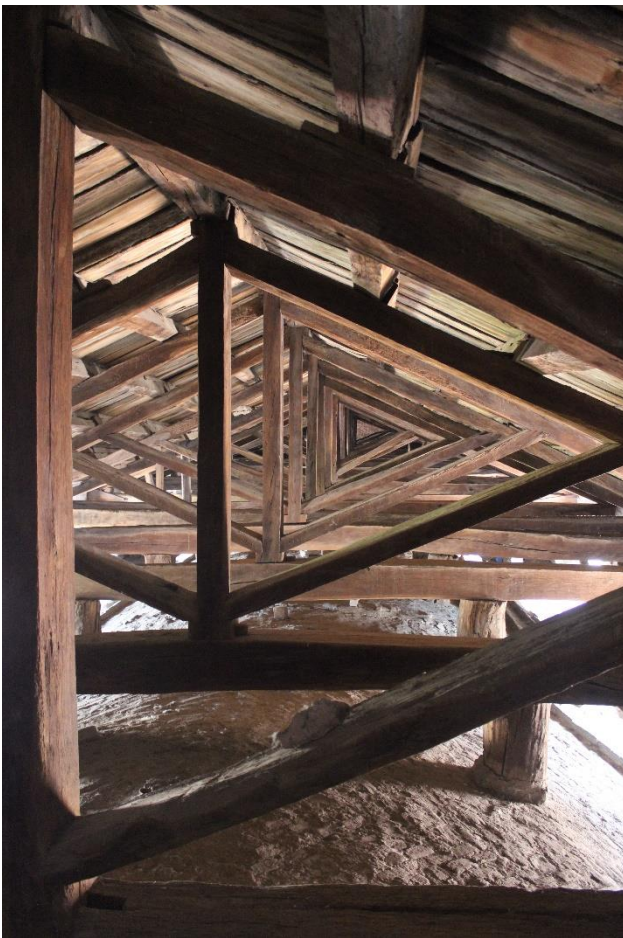
Figure 7: On the left, roof of the nave; on the right view of the southern aisle attic.

The roof of the southern aisle has thirty-two rafters placed at a small distance (ca. 170 cm, three Cremonese arms and a half, in the first construction phase; 195 cm, four Cremonese arms, in the second), supporting six rows of purlins with notches for the polychrome laths, also in this case still preserved in some specimens. In two areas, the roof of the south aisle was lowered when the vaults were built, to allow light to enter the nave through large semi-circular windows specially opened in the wall that separate the nave from the aisle. As for the rafters of the southern aisle, the relationship with the masonry in the first and second construction phases is different from that of the trusses of the nave. The rafters of the first phase were arranged at an almost uniform spacing, but completely indifferent to the position of the pillars of the nave; instead in the second phase there is a rafter in correspondence of each pillar and three intermediate rafters.

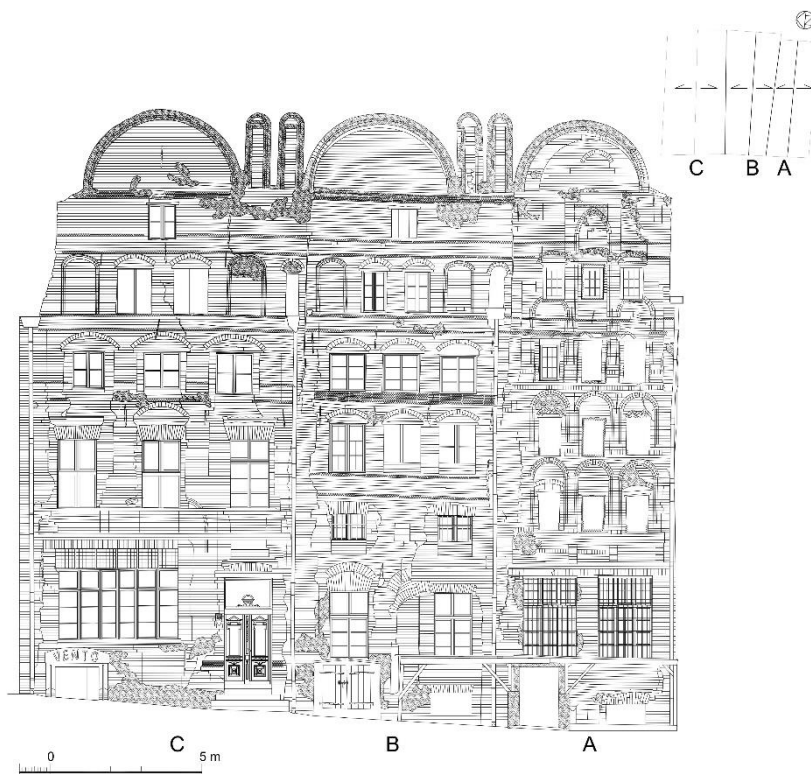
Fig. 1. Toruń, 6 Mostowa Street. The front elevation of buildings A, B and C (compiled by U. Schaaf, M. Prarat).

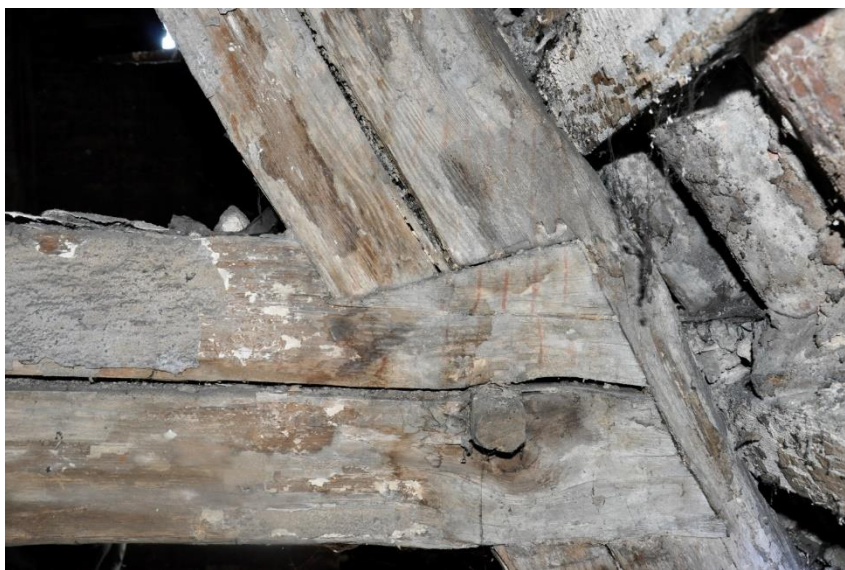
Fig. 3. Toruń, 6 Mostowa Street. Roof structure of building C. A carpenter's assembly mark made with a sanguine (Photo by U. Schaaf).

round marks were used, and on the right rafters - bar marks. The latter extend partially through the whole joint (Fig. 3), so they simultaneously fulfil the function of so-called matchmarks (in German "Passzeichen"). The king struts from west to east were marked separately, from 1 to 8, with an increasing number of Xs, made with either a carpenter's adze or sanguine.

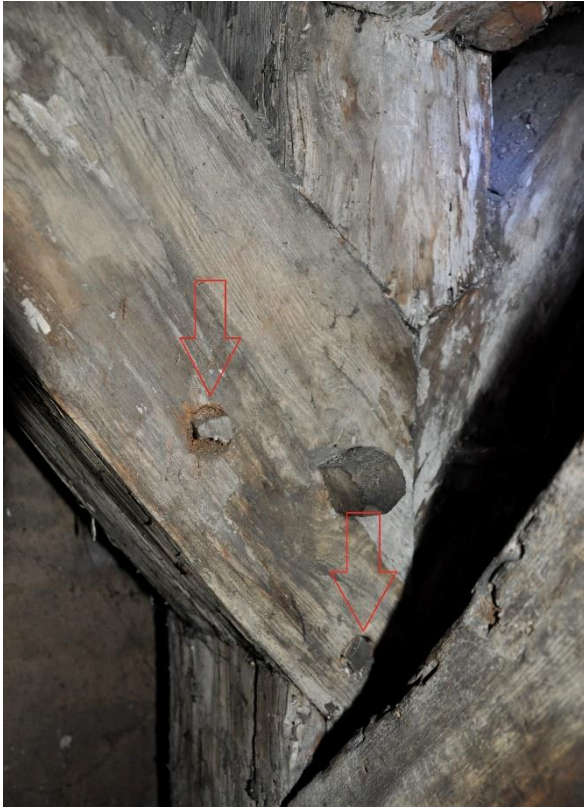
Fig. 4. Toruń, 6 Mostowa Street. Roof structure of building C. Traces of raft floating of the building material (Photo by U. Schaaf).

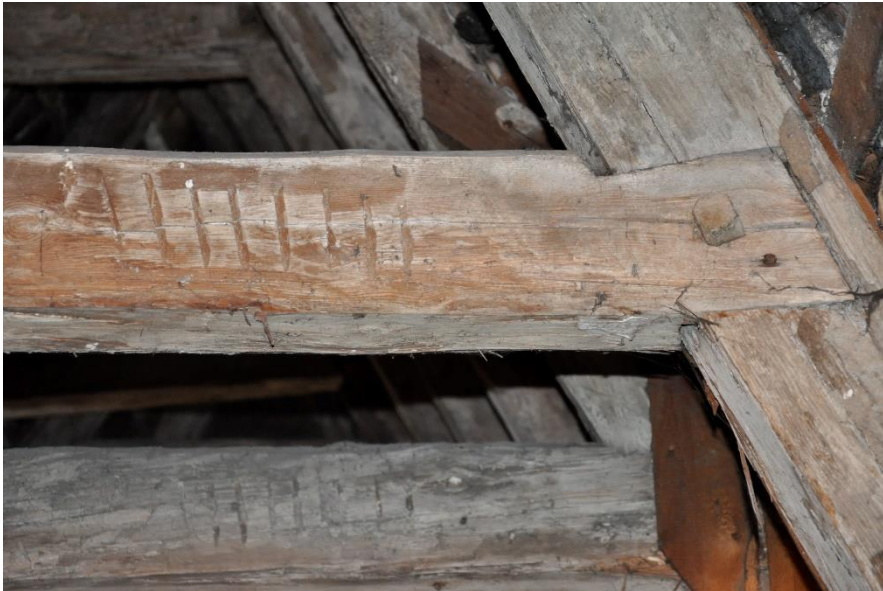
*Fig. 6. Toruń, 6 Mostowa Street. Roof structure of building B. The connection of the rafter with a collar by means of a single dovetail lap joint (Photo by U. Schaaf).*

notch when connecting the wall plate with the tie beams, a barefaced tenon joint when joining the rafters with the tie beams, a straight lap joint when connecting the rafters in the ridge, and a stopped single dovetail lap joint when connecting collar beams with rafters (Fig. 6).

During timber framing, the structural elements of individual trusses were marked with triangular cuts on the left and simple bar marks on the right (Fig. 6). Their number increases from west to east from 1 to 15. In this way, each element was assigned a specific place in the spatial structural system. The triangular signs were made with a stylus and a chisel, and the bar marks were made with a stylus and a hand adze.

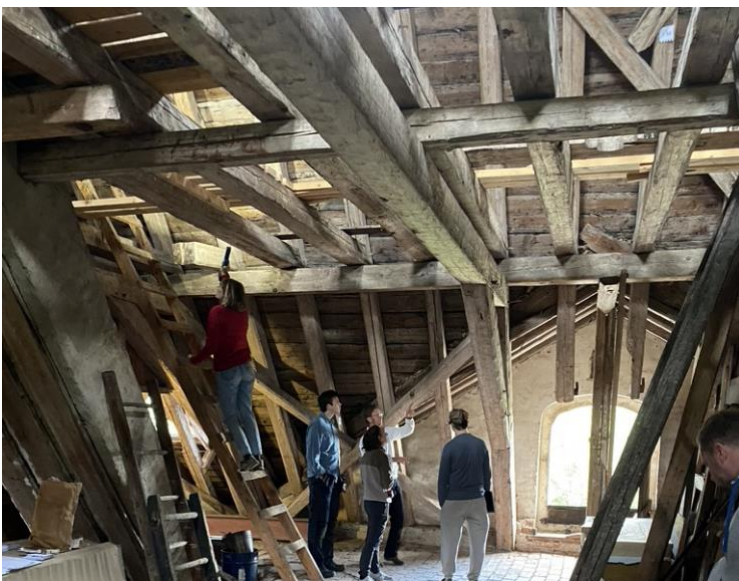
*Figure 1: Timber roof structures of Louhisaari Castle. Photo: Panu Savolainen.*

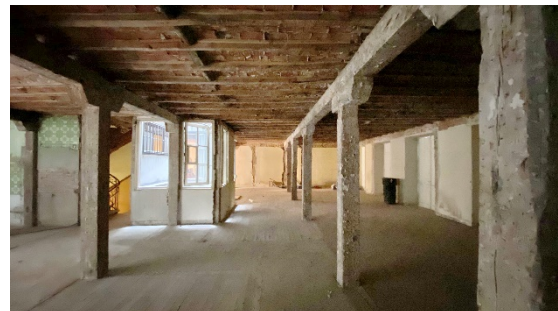
Figure 2: Timber structure (initial state).

The building has a ground floor plus three complete floors, one more under the roof -with a smaller surface area- and a partial underground area- located at the back. Each floor has an approximate surface area of 250 m<sup>2</sup>. The vertical and horizontal structure is entirely made of wood and, initially, the owner company was asked to demolish all the supported construction systems, keeping only the wooden load-bearing structure, in order to study it. (Figure 2: ).

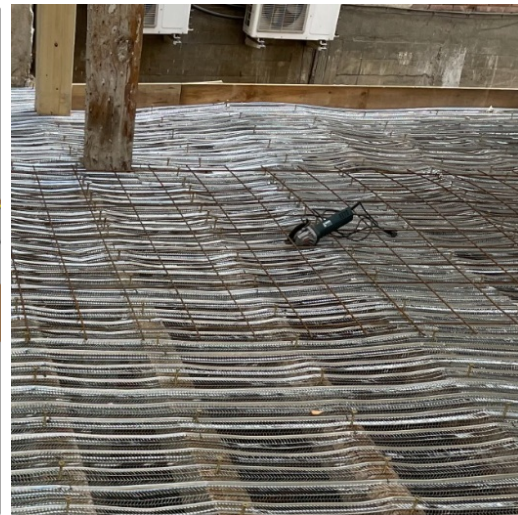
Figure 4: Laying of the mixed floor slab.

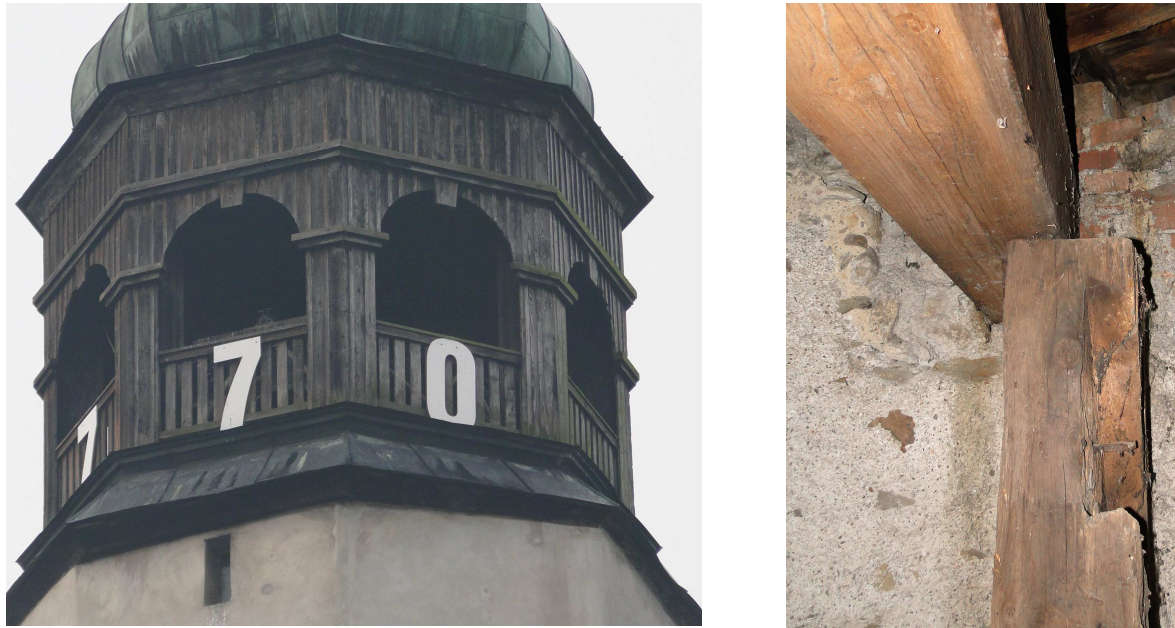
Figure 1: Lower lantern of the tower (left). Element connecting the structure of the lantern with the masonry core of the tower (right)

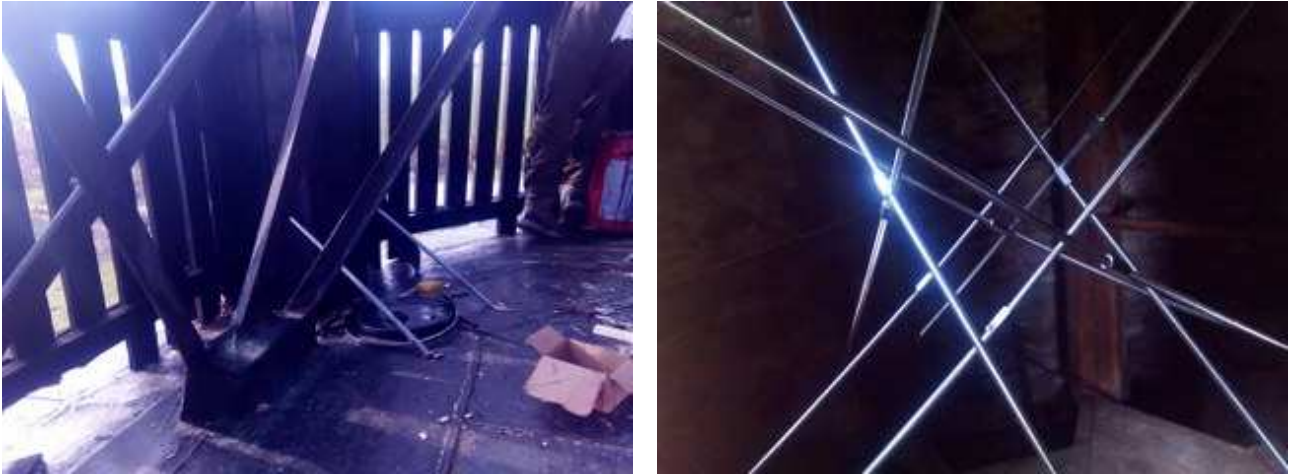
*Figure 3: Example of strengthening construction outside (left) and inside (right)*

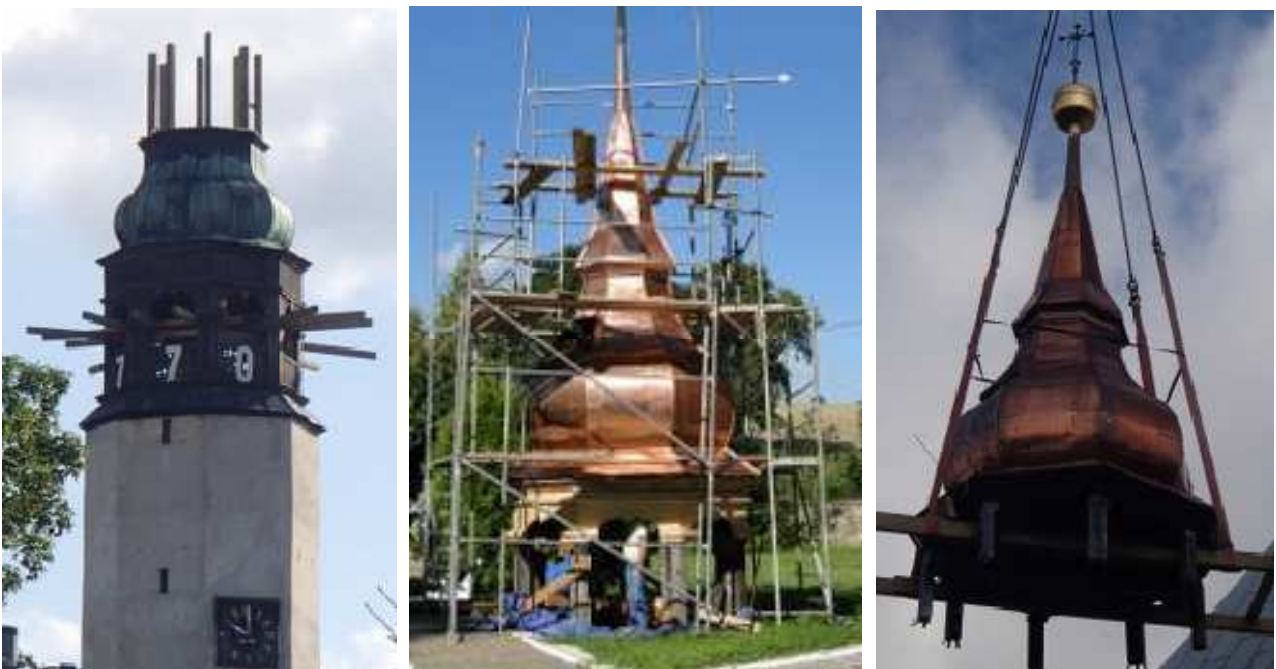
*Figure 4: Removed upper dome for repair works (left) Repair of the upper dome on ground level (centre) Lifting repaired upper dome (right)*

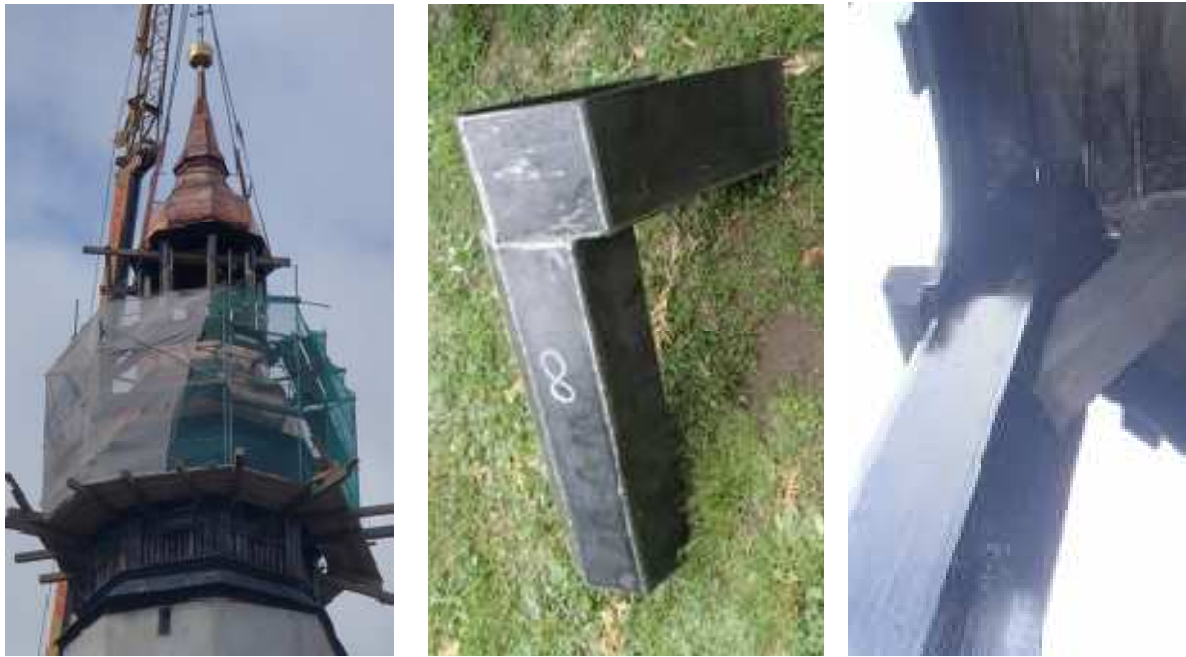
*Figure 4: Repair of the upper dome on ground level (left) Connector for fixing upper dome (centre) After fixing (left)*

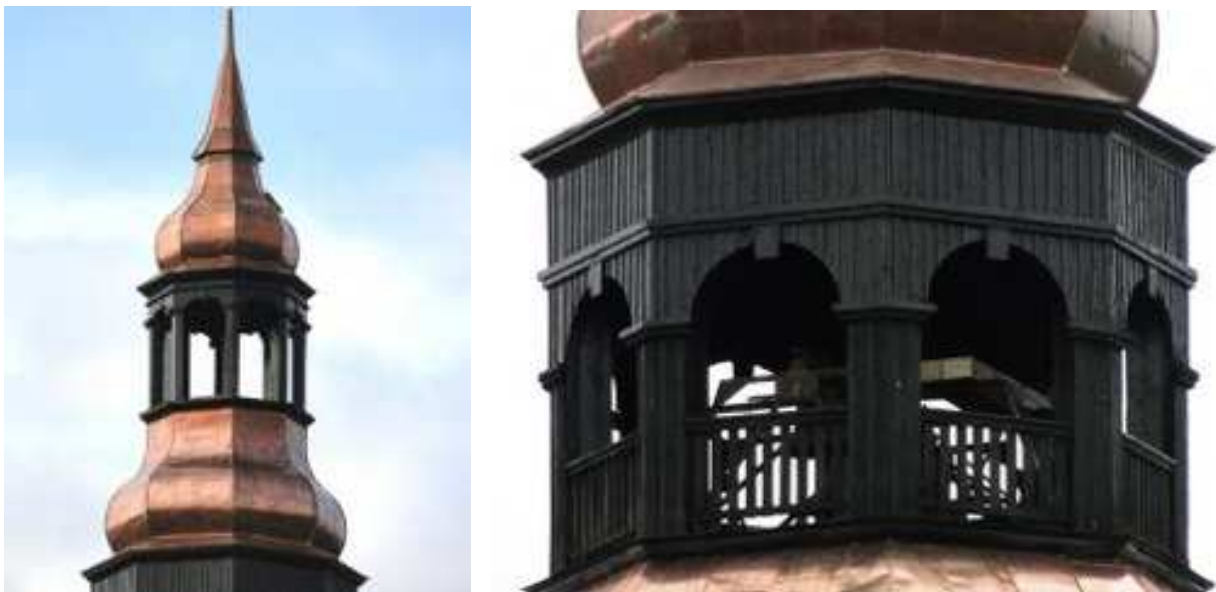
*Figure 5: Upper (left) and lower (right) lantern of the tower after works*
